NBS TECHNICAL NOTE 909

Investigation of Wind Damage in the Metropolitan Washington, D.C. Area, April 3-4, 1975

F. Y. Yokel, C. W. Yancey,
L. E. Cattaneo, and R. D. Marshall

A limited investigation was conducted of wind damage that occurred on April 3 and 4, 1975 in the Metropolitan Washington, D.C. area.

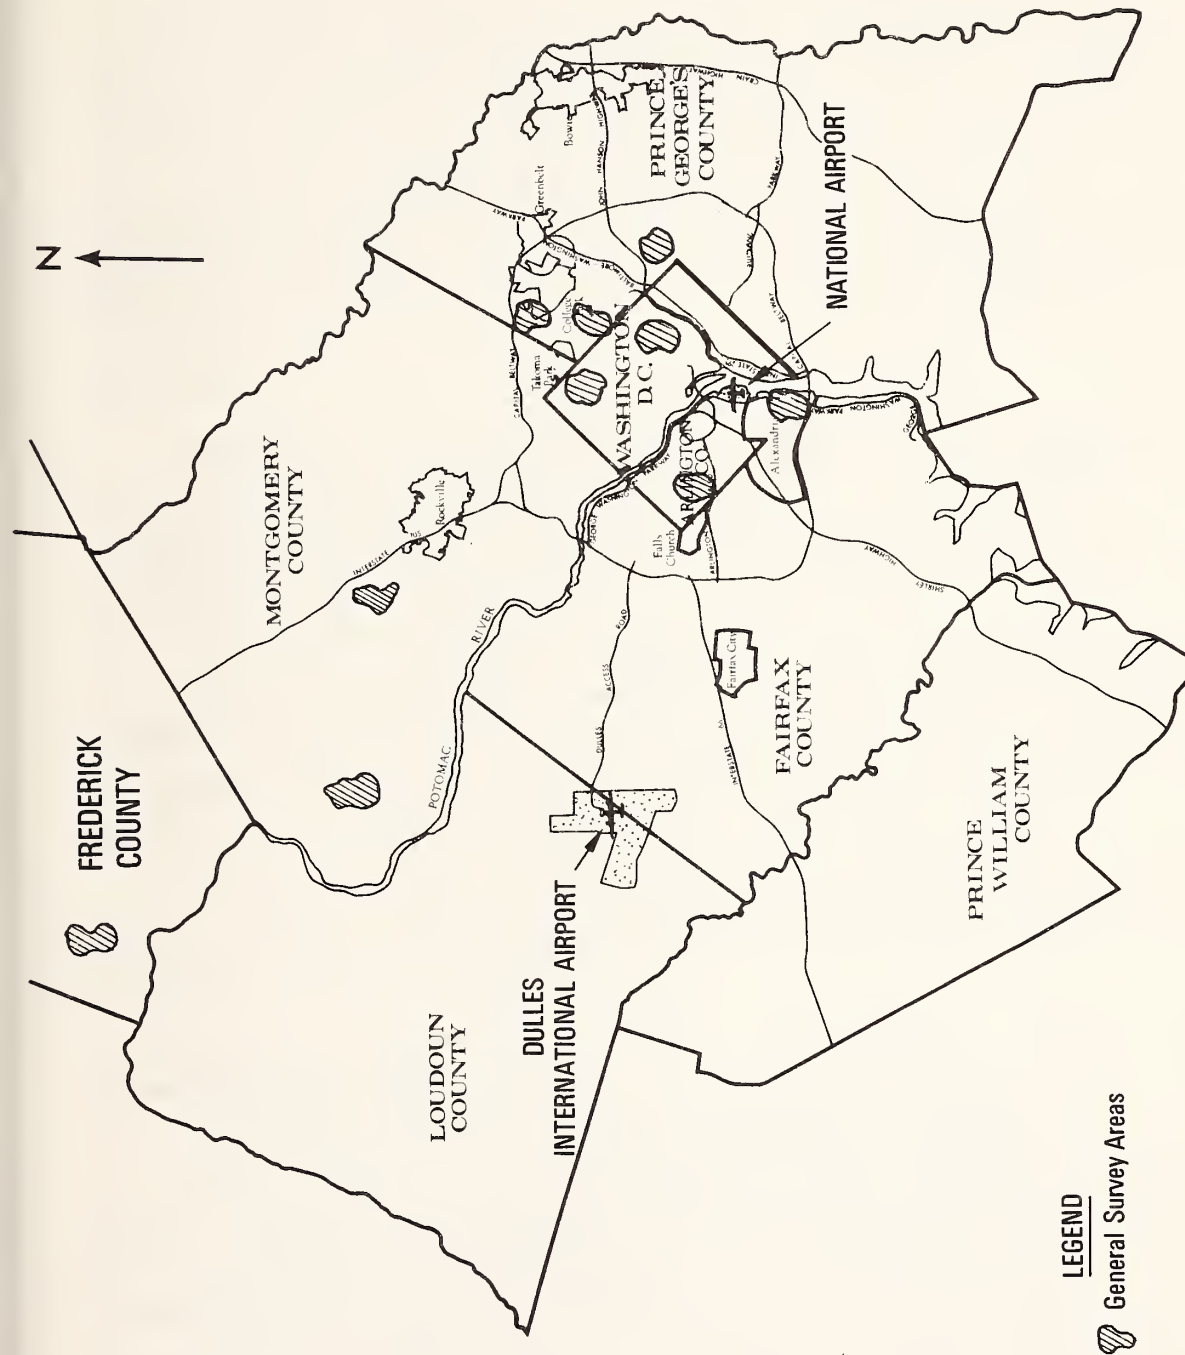
Figure 1 - Metropolitan Washington Area

Continuous records of wind speeds for the period April 3-4 were obtained by the National Weather Service at stations located at Washington National Airport, directly across the Potomac River from the District of Columbia, and at Dulles International Airport, approximately 21 miles (34 Km) to the west. Both anemometers have typical airport exposures and are located 20 feet (6.1 m) above ground level. The locations of the observation points are shown in figure 1.

The survey included occupied buildings and buildings under construction. The general areas where building damage was surveyed are indicated in figure 1. (hatched areas).

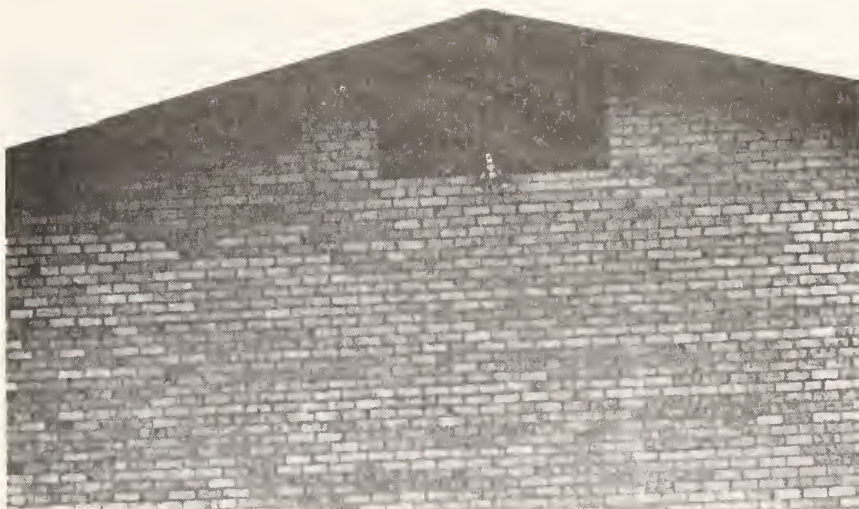
Figure 20 - Elevation view of an undamaged gable wall.

An overall view of the damaged building under repair is shown in figure 18. Figure 19 shows a closer view of the damaged wall and roof overhang. Figure 20 shows a similar undamaged wall in an adjacent building.

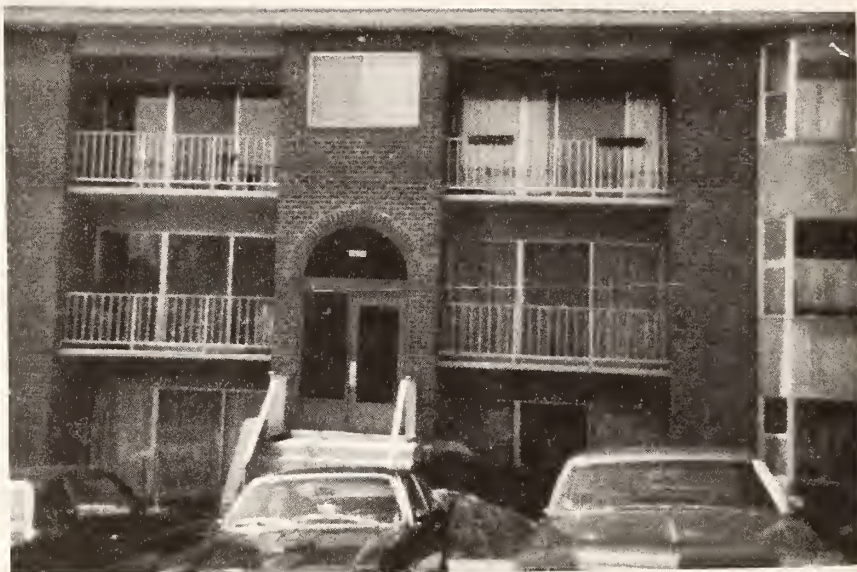
Figure 27 - Front elevation of a typical three-story apartment building.

Figure 27 shows a front elevation of a typical three-story unit of a garden apartment complex with flat mineral surface built-up roofs. Figures 28 -31 show overall views of the roof damage suffered by the apartment complex. The prevailing wind direction is shown in figure 28. The figure also shows that the roofs overhanging the balconies were ripped off by the wind. The view through the window on the upper left of figure 29 shows that part of the roof and ceiling over the living unit is removed. Another front view of the damage is given in figure 30 and a side view in figure 31. Figure 32 shows some of the debris of the collapsed roof. The roof construction consisted of 2 x 8 (5 x 20 cm nominal) wooden joists 24 inches (61.0 cm) on centers with plywood on both sides of the joists. This flat roof was then covered with a composite roofing. No information was available on the anchorage between the joists of the roof structure and the masonry walls of the building and no evidence of anchorage could be found in the field examination. Apparently, the wind exerted substantial uplift on the overhanging portions of the roof and in particular on sections of the roof covering the balconies. Evidence of this uplift can be seen in Figure 33. Note the separation between the roof (which is in this case still in place) and the masonry wall. Figure 34 shows that the portion of the roof overhanging the balcony was supported by a beam which in this case stayed in place while the roof was demolished. In figure 35 a case is shown where the beam was also pulled out from its bearing socket. An overall view of the roof under repair is shown in figure 36. The areas under repair in this figure give an indication of the extent of the damage suffered.

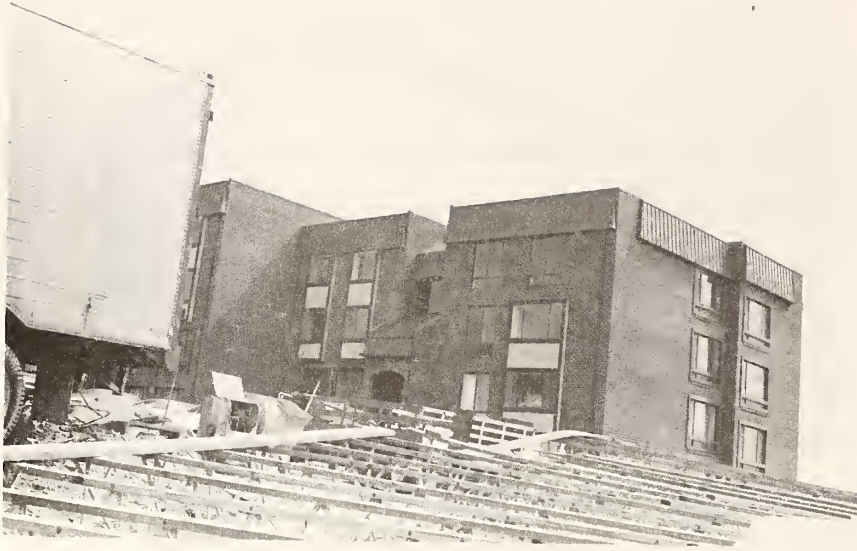
Figure 37 - A completed three-story garden apartment building.

Figure 37 shows a three-story garden apartment building. This is one of the completed units which suffered no damage. Figure 38 shows a row of the same type of units under construction. The prevailing wind direction is indicated by the arrow. Note that in the completed unit (figure 37) the truss structures which support the roofs are closed by siding, giving the appearance of a mansard. Figure 38 shows part of the roofs which were removed by the wind and deposited in front of the buildings under construction. A closer look at an undisturbed roof assembly in place is shown in figure 39. Figures 40 and 41 show details of the roof assemblies which were lifted up, overturned and deposited on the ground. The truss structure had wooden top and bottom chords and galvanized steel tubing as diagonal truss members. The top of the roof was covered by 1/2 in (1.3 cm) thick plywood sheathing. Although this plywood sheathing was in place, the built-up roofing had not yet been installed. The span length of the trusses was 49 ft (14.9m) and spacing between trusses was 24 in (61.0 cm). Connections of the roof trusses to the masonry walls are shown in figures 42, 43 and 44. Figure 44 shows that not only was the roof truss structure removed, but also a steel beam which served as a lintel over a window opening. One of these lintels, in place, is marked by the arrow in figure 45. Two of the displaced lintels are seen, still attached to the trusses in figure 38. The failure of these roofs is probably attributable to two causes: 1. the sides of the trusses were open and the windows were not completed, thus providing openings which caused pressure buildup on the underside of the roof sheathing; this pressure, together with suction acting on the top of roof surface exerted a considerable upward force; 2. the built-up roofing was not yet in place to add weight which could have contributed to the resistance to uplift pressure. Figure 45 shows the details of roof trusses on units which were under construction and which were not damaged by the wind.

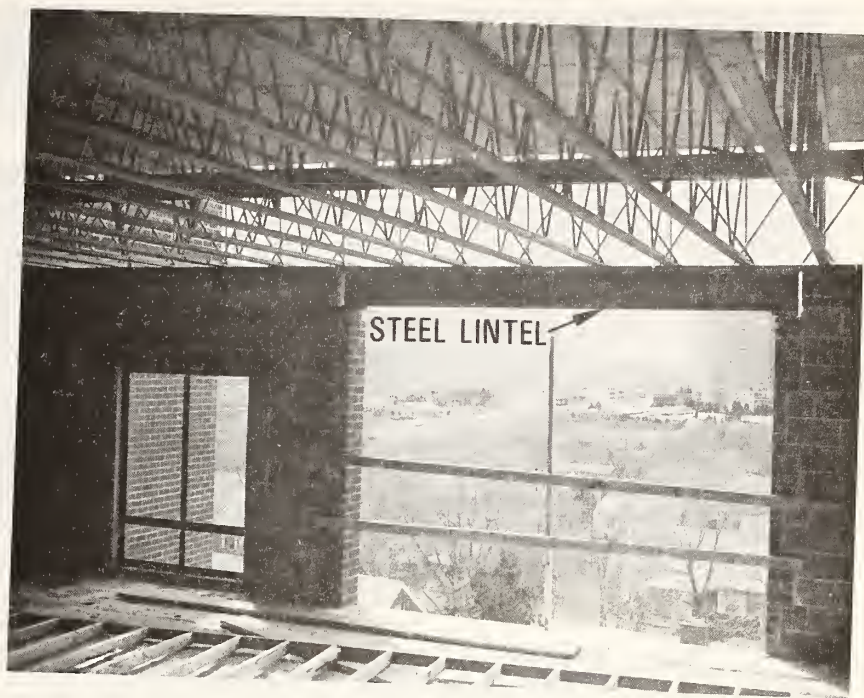
Figure 39 - Closeup view of the underside of a typical roof assembly.

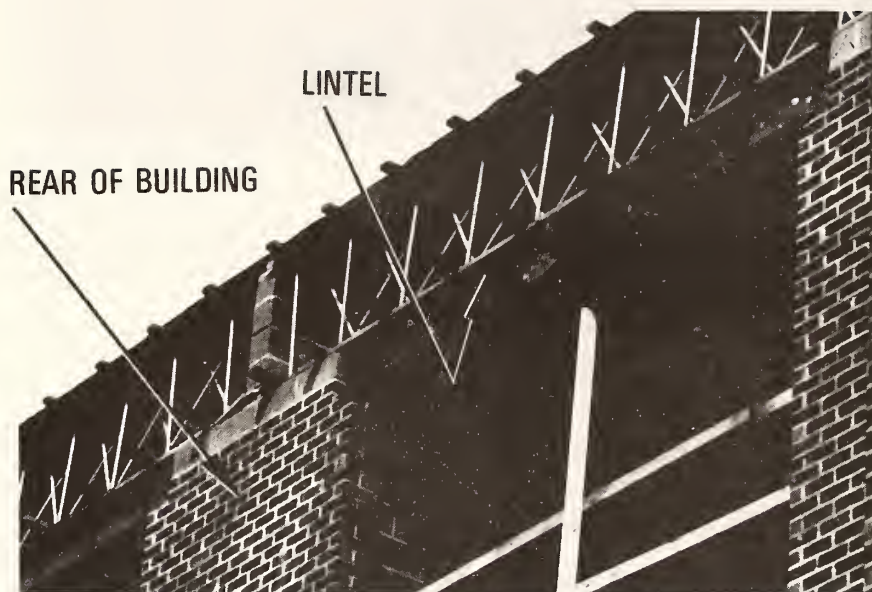
Figure 45 - Rear view of roof truss support in an undamaged building. Looking east.

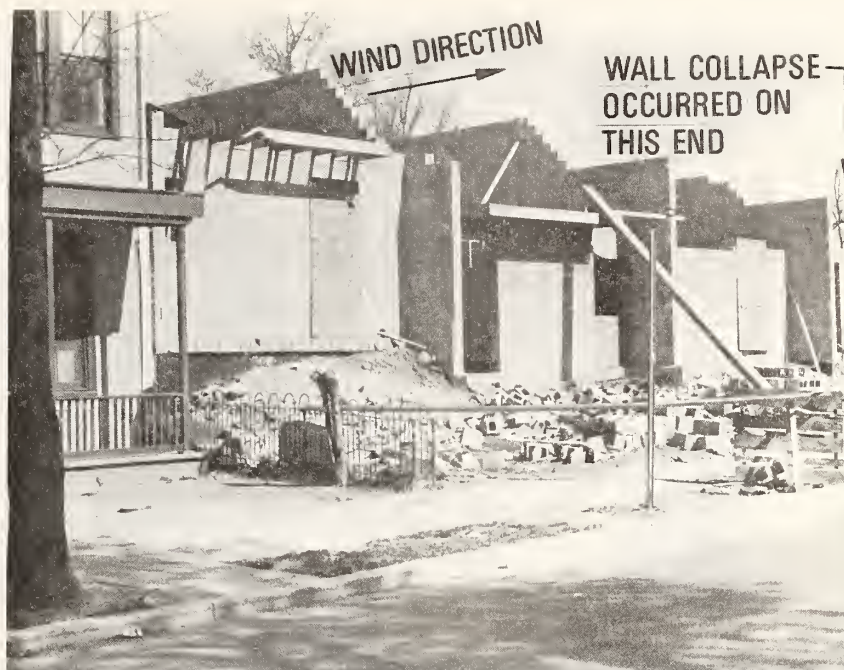
Figure 46 shows the end unit of a four-unit concrete masonry row house under construction. The exterior side wall of this unit collapsed and fell into the street causing two fatalities. (See the debris in the foreground of the photograph). Figures 47 and 48 are other views of the same structure taken from another street at right angles to the one into which the wall collapsed. The direction of the prevailing wind is shown by the arrow in figure 47. Note the partial collapse (figure 48) of cross-walls in other portions of the structure which were parallel to the exterior wall that collapsed. Details of the pulled-out joint reinforcement in one of the damaged cross-walls is shown in figure 49. The construction was 8 in (20 cm) unreinforced hollow concrete block with joint reinforcement. The incident illustrates the vulnerability of masonry walls in the construction stage before they are fully braced at their tops.

Figure 47 - Front elevation of three of the living units in row house complex.
